UNDERWATER BRIDGE INSPECTION REPORT

STRUCTURE NO. 27611

PLYMOUTH AVENUE

MISSISSIPPI RIVER

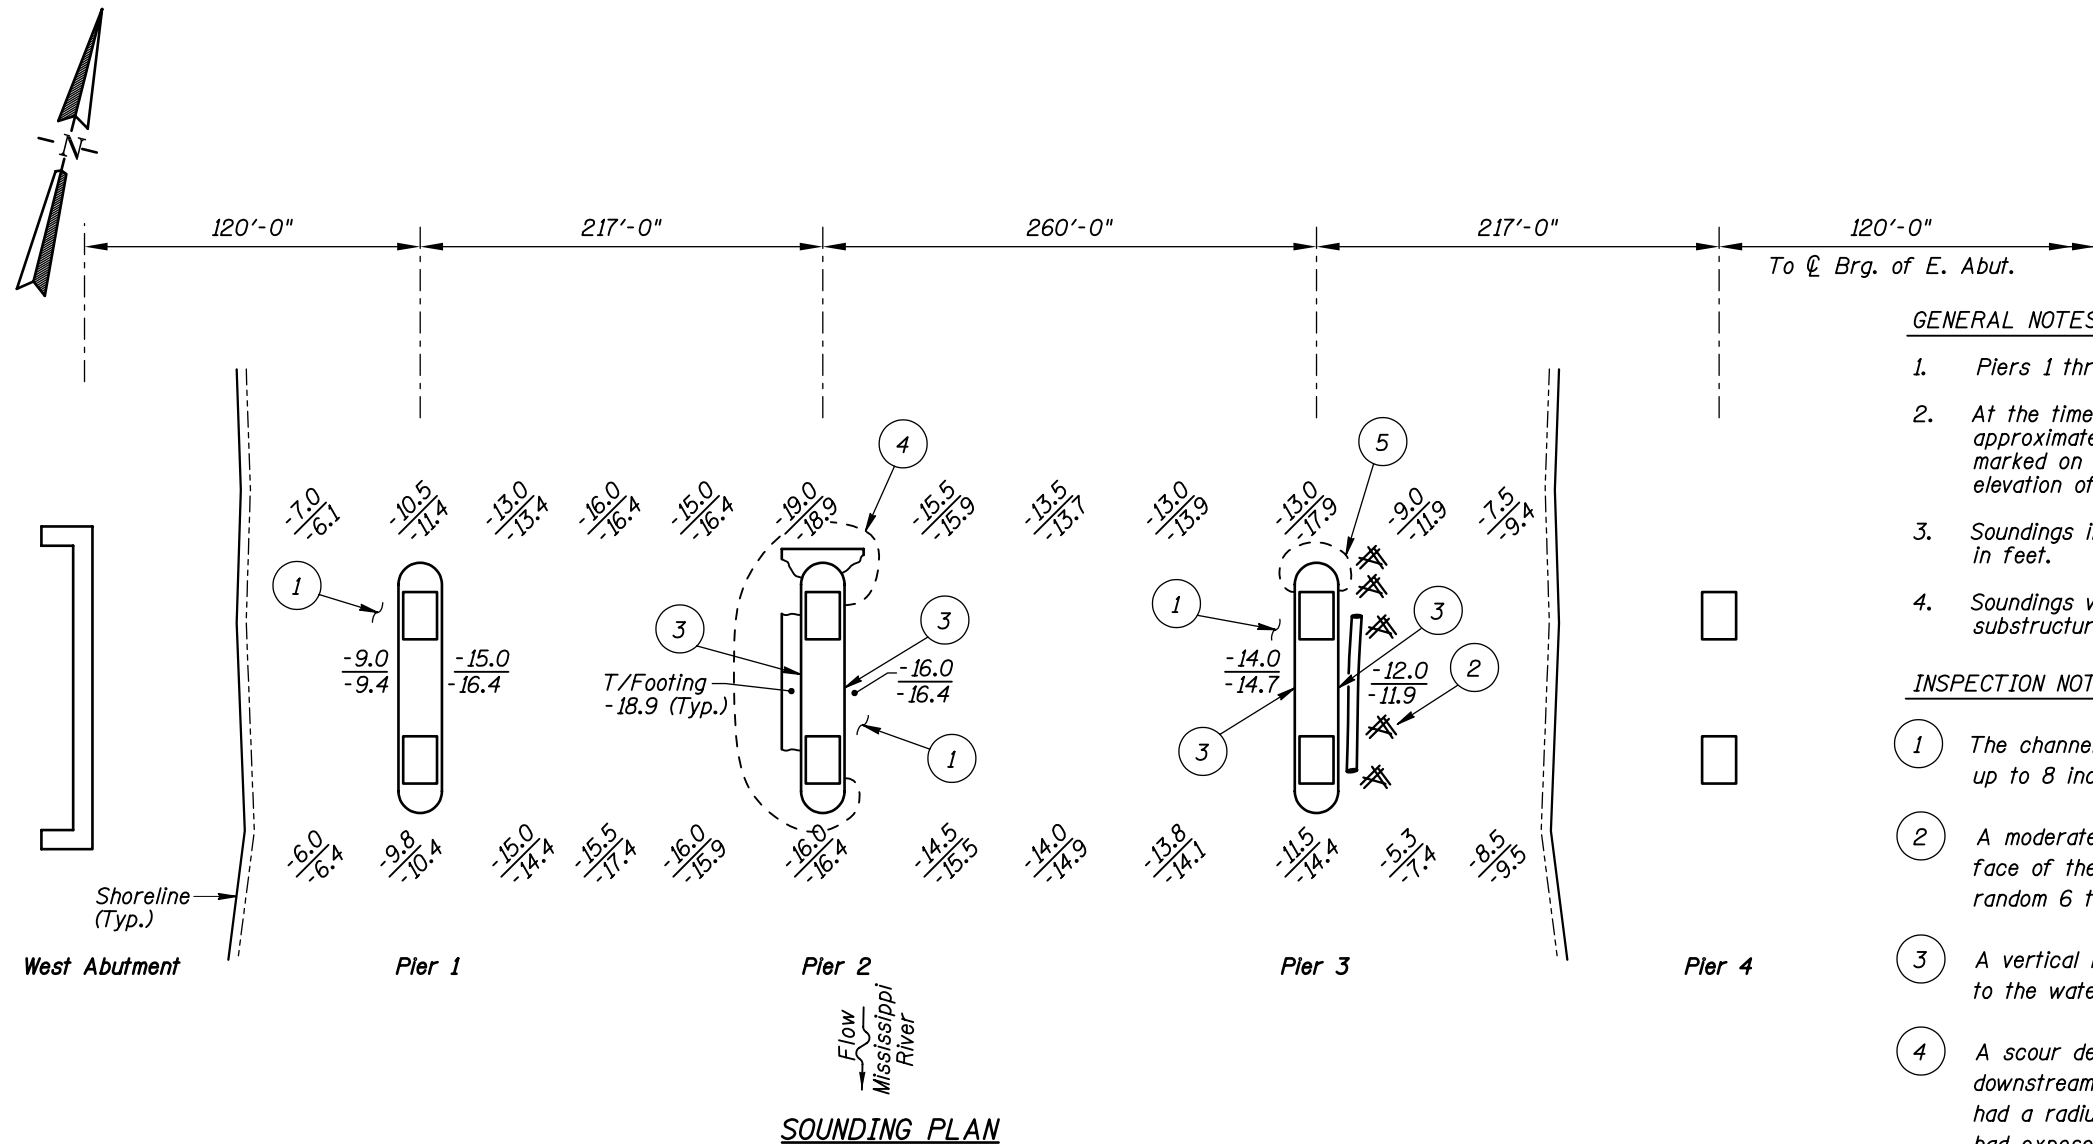
INSPECTION AND SOUNDING PLAN

- The channel bottom material consisted of silty sand and gravel with up to 8 inches of probe rod penetration.
- A moderate accumulation of timber debris was observed along the east face of the pier. The debris consisted of a 2 foot diameter log and random 6 to 12 inch diameter debris.
- A vertical hairline crack was observed from the top of the web wall to the waterline.
- A scour depression was observed from the upstream nose to the downstream nose and all along the west face of the pier. The scour had a radius of about 8 feet and a maximum depth of 3 feet. The scour had exposed the pier footing at the upstream nose and for 30 feet along the west face of the pier with 1 inch and no vertical face exposed on the footing, respectively, at the two exposure locations.
- A scour depression with an 8 foot radius was observed with a maximum depth of 3 feet.

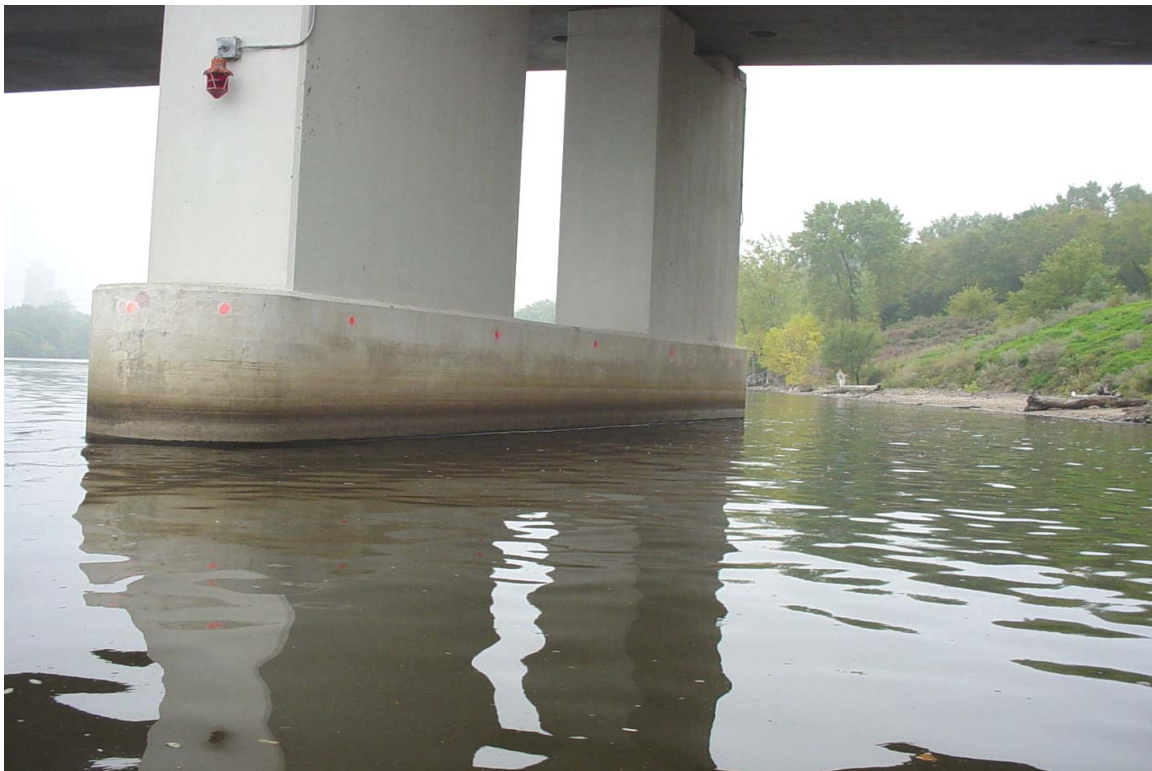
Photograph 2. View of Pier 1, Looking Southeast.

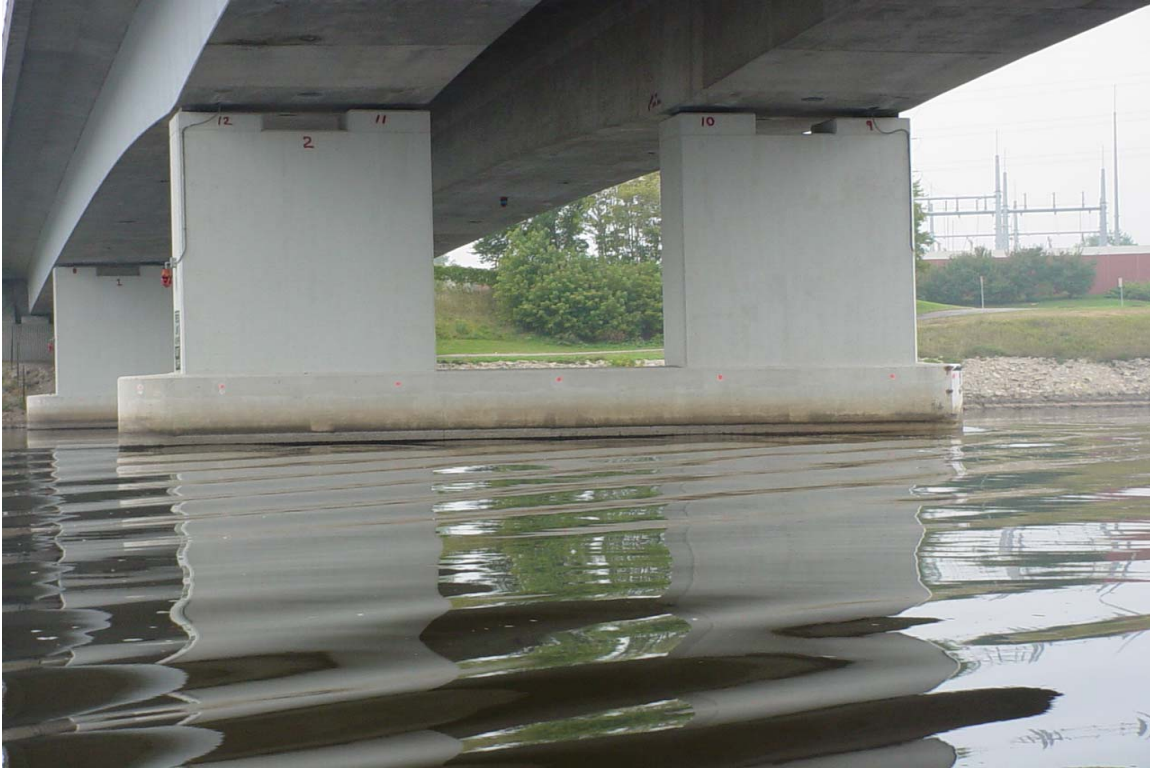
Photograph 3. View of Pier 2, Looking Northwest.

- (A) Monitor the footing exposure and scour at Pier 2 and local scour at Pier 3, and if found to be increasing in the future, countermeasures may become warranted based on the findings of the scour analysis/rating done in 1996.

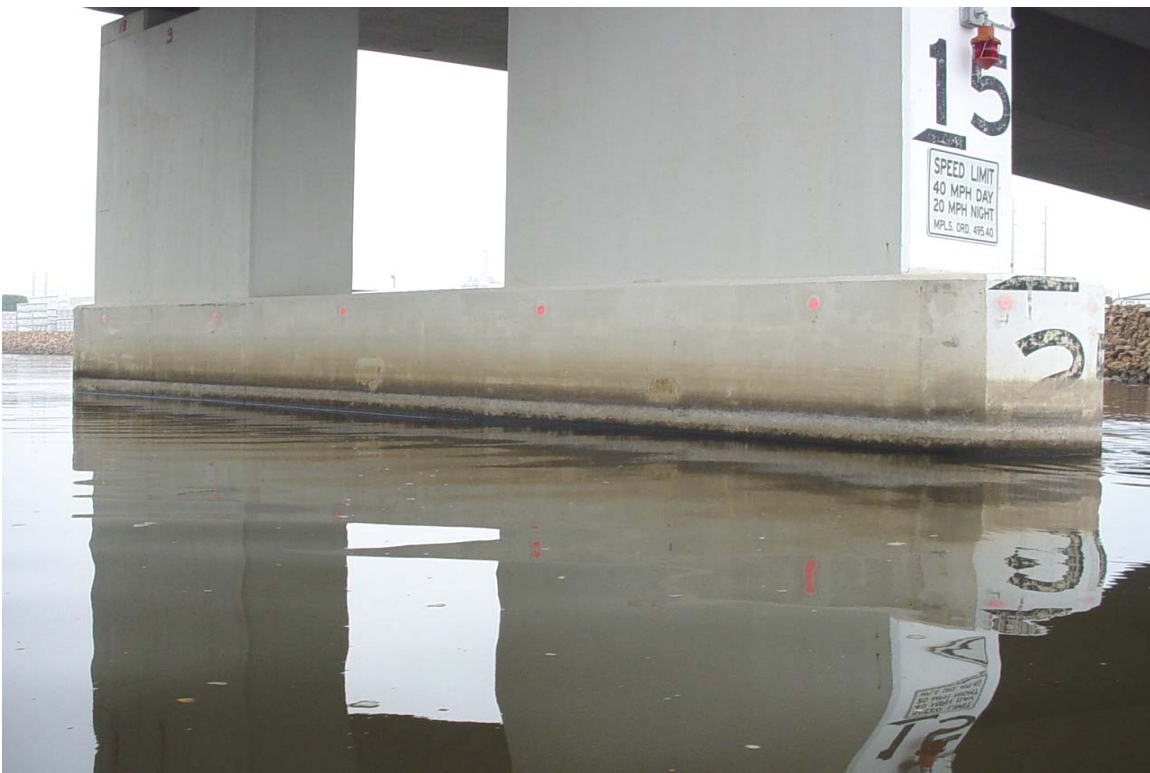
Photograph 4. View of Pier 3, Looking Northeast.

- (B) Monitor the accumulation of timber debris at Pier 3, and if found to be increasing in the future, removal operations may become warranted.
- (C) Reinspect the submerged substructure units at the normal maximum recommended (NBIS) interval of five (5) years.
